FABRIC DEFECTS

CASE HISTORIES OF IMPERFECTIONS
IN WOVEN COTTON AND RAYON FABRICS

J. B. GOLDBERG

Fellow of the Textile Institute
Research Director, J. P. Stevens & Co., Inc.

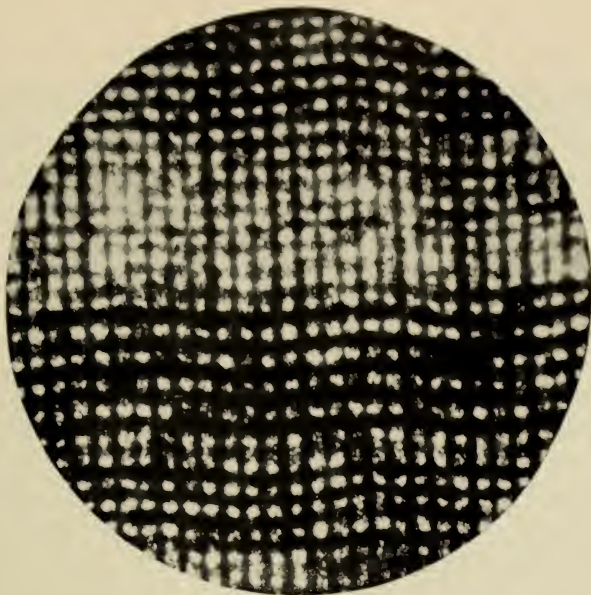
FIG. 2a. Thin spots due to broken filling yarns (transmitted light).

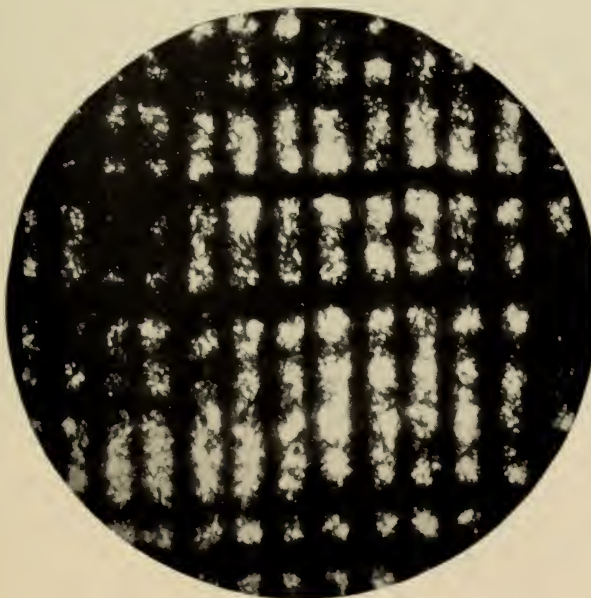
FIG. 2b. Same at higher magnification.

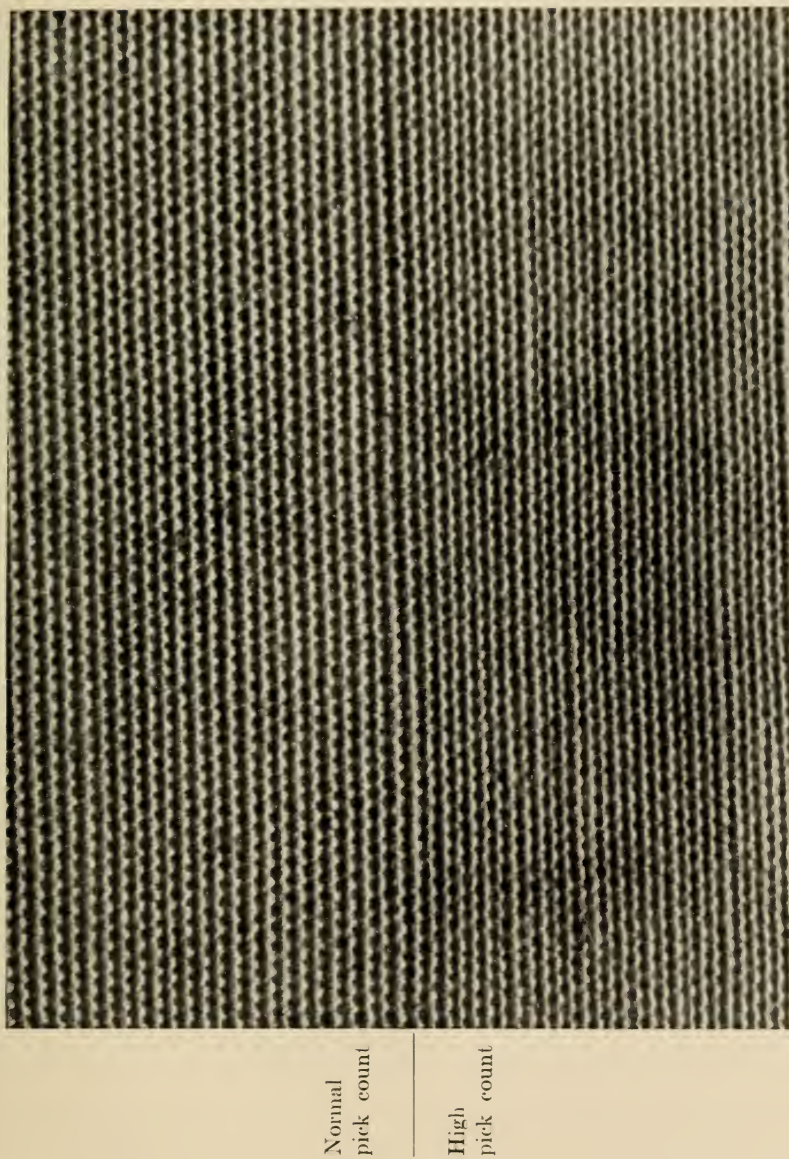
Analysis showed that the shade bands were actually an optical illusion caused by variations in pickage or set marks in the weaving. In the light-appearing sections there were 25 picks per $\frac{1}{4}$ inch, whereas in the darker adjacent $\frac{1}{4}$ inch there were only 20 picks. Where the pick count was high, the dyestuff penetration was less and there was a very narrow light band. This band was never more than about 1 inch in width, the pick counts gradually returning to the normal. To prove that the apparent shading was an optical effect, small cuttings from the light and dark bands were removed about 2 inches from the distinct shade change and substituted for each other. The shade match was perfect, showing no difference existent beyond the narrow section where the pick count was abnormal. Such set marks, or starting-up places, are fairly common in some constructions and may be due to faulty loom take-up or let-off, or to a sagging of the warp during exceptionally long periods of its standing with the shed open.

FIG. 3. Band due to pickage variations.

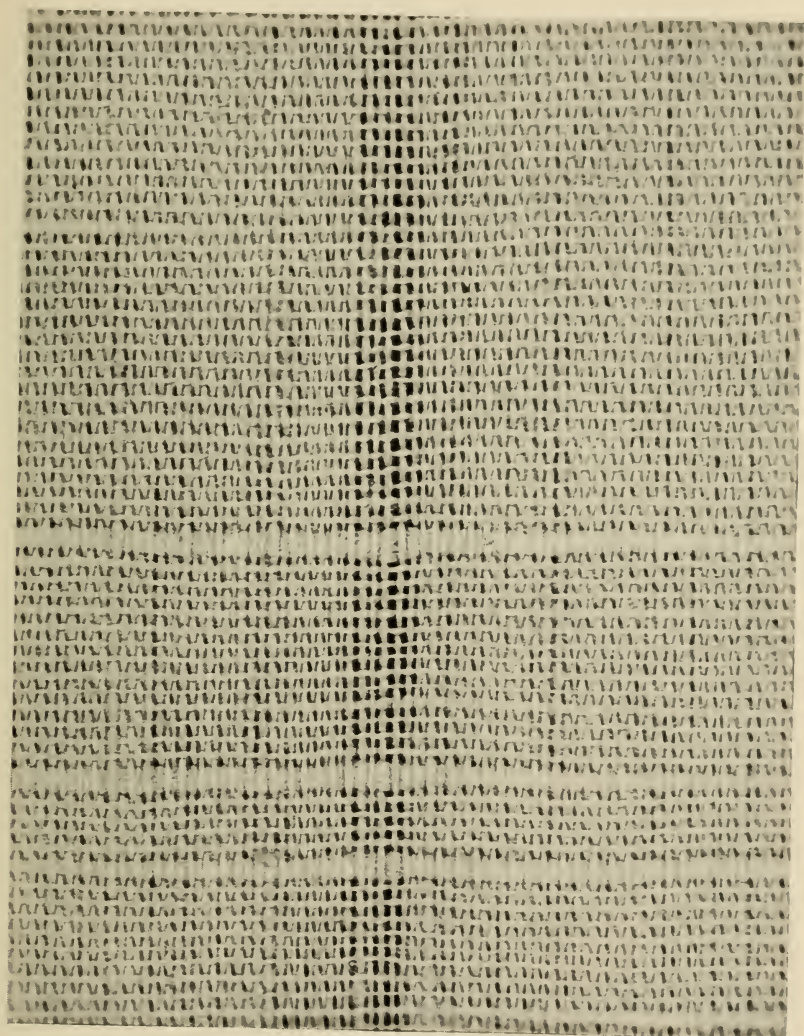
As in the case of many other fabric defects, the degree or intensity of this type of imperfection may vary greatly. In some cloth constructions a slight "reedy" condition in the gray goods may be so minimized in finishing that an experienced inspector in the weaving-mill cloth room would be justified in passing the goods as first quality. The example described in this instance, however, as disclosed in the accompanying photomicrograph, is typical of an extreme condition which would normally be detected and classified as a "second" by the mill.

Fig. 4. Streak due to reed mark.

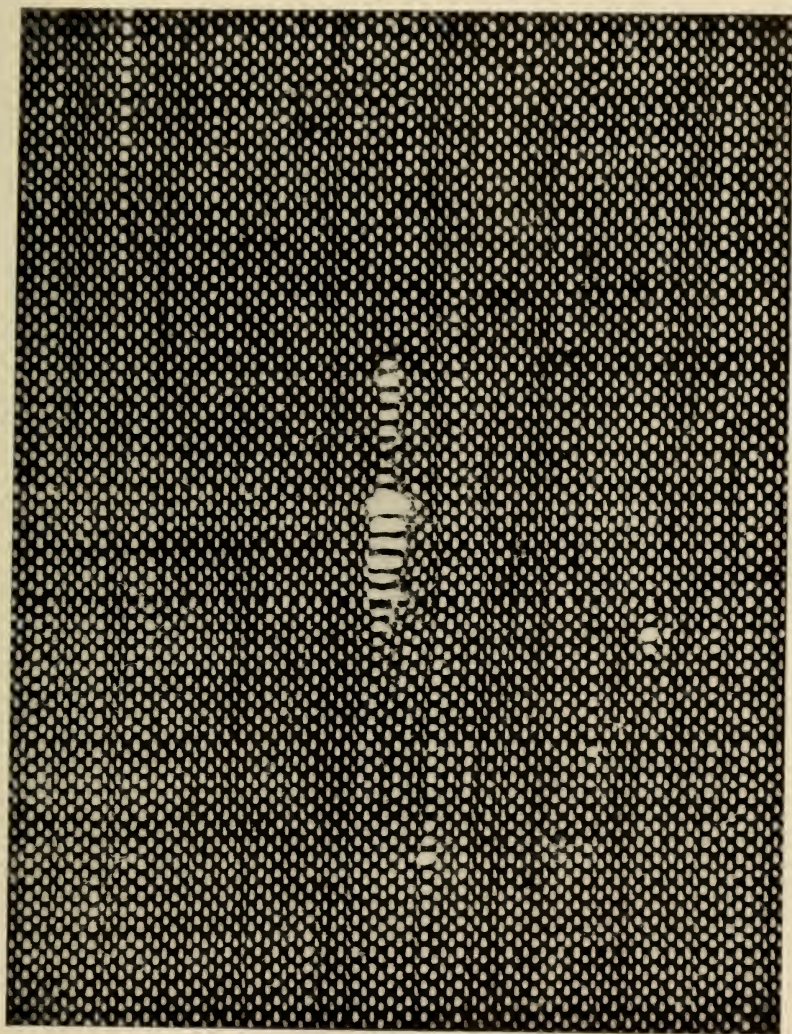
Examination showed that the streaks were due to thick and thin places and excessive slubs in the filling yarn. The unevenness of these yarns was confirmed by the weighing of short sections, as well as by examination of several yards removed and wrapped on a blackboard by a hand seriplane. By actual measurement, the yarn was found to vary from as fine as 51/1 to as heavy as 37/1 within 1 yard. This defect was attributed to a poor quality of filling yarn, particularly detrimental to the appearance in a chambray of this type because of the greater contrast between the white and the dyed yarns.

FIG. 5. Poor quality filling yarn.

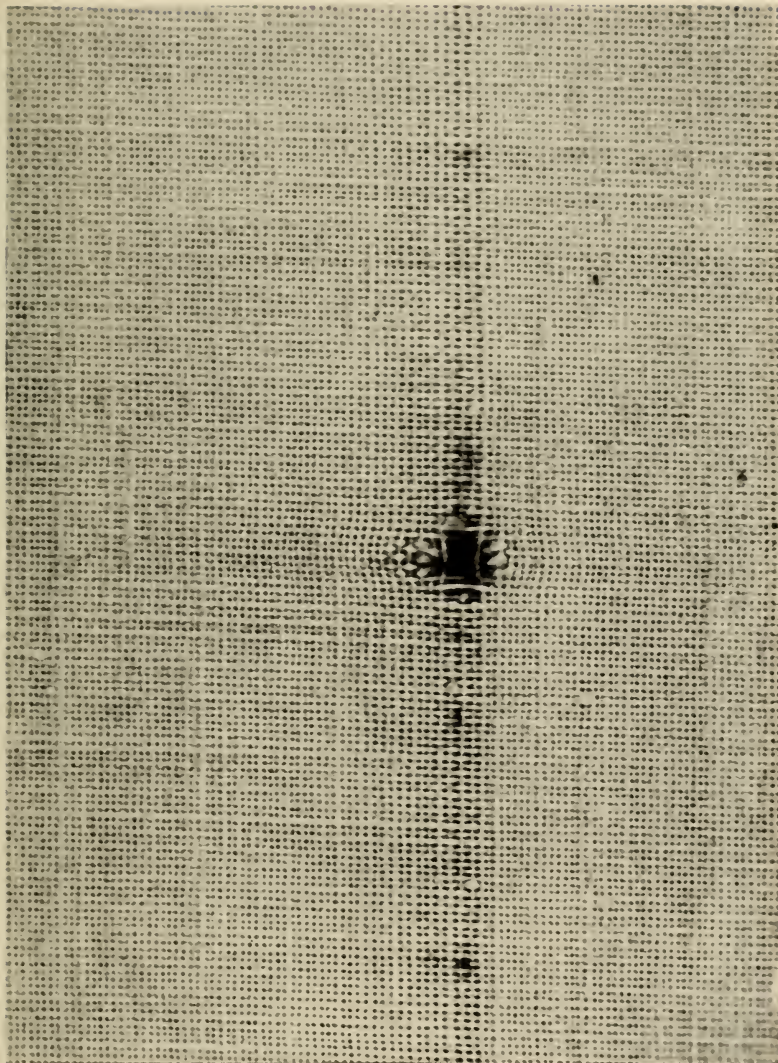
Examination showed that, wherever the small holes were present, there were thin places in the fabric resulting from set marks, or loom starting-up places, where the pickage was much less than the normal. When goods containing this kind of imperfection are singed in the finishing plant by passing them over open gas flames, there is the danger of the flame's shooting through the more open places and burning small holes in the cloth. It was noted that there were brownish scorched areas around the holes, which confirmed the fact that the damage was produced by burning.

FIG. 6. Singe holes due to thin places in filing.

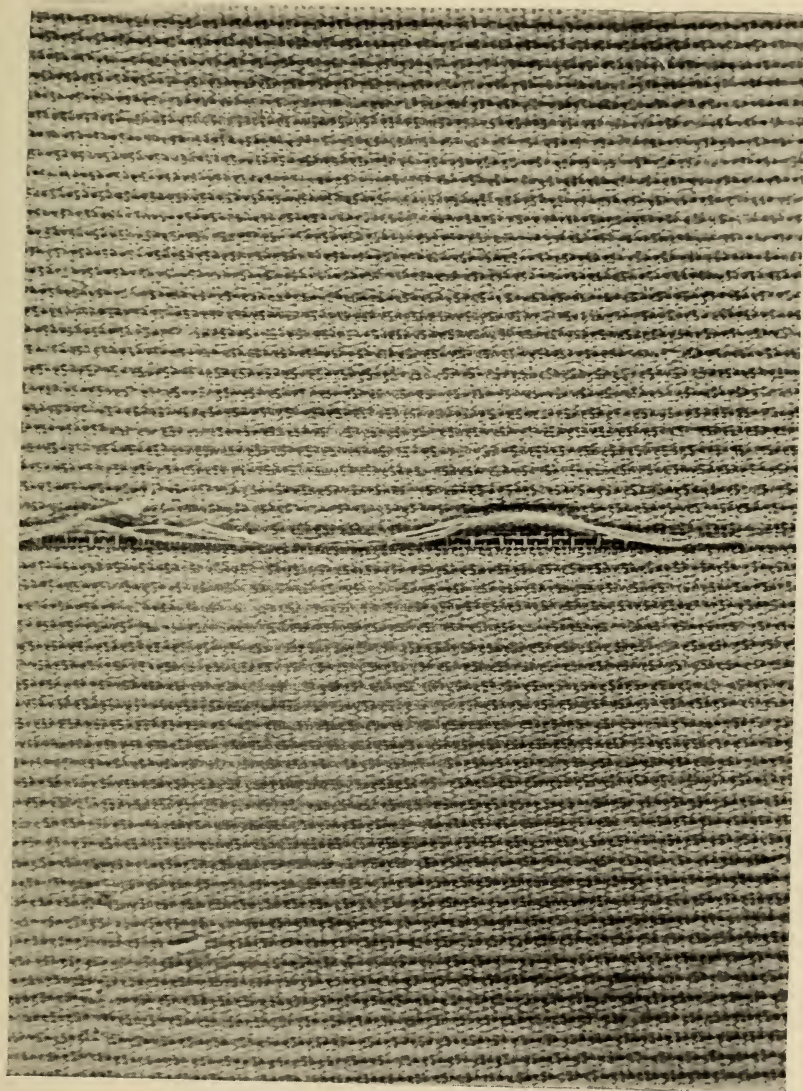
Analysis showed that, whenever the defect appeared, there were several wrong draws in the goods. In some places as many as three ends were found weaving as one. In the sueding (napping) operation, the picks were sufficiently weakened in these places to break through and allow the warp ends to float loosely on the surface.

FIG. 7. Ends improperly woven and broken out during napping.

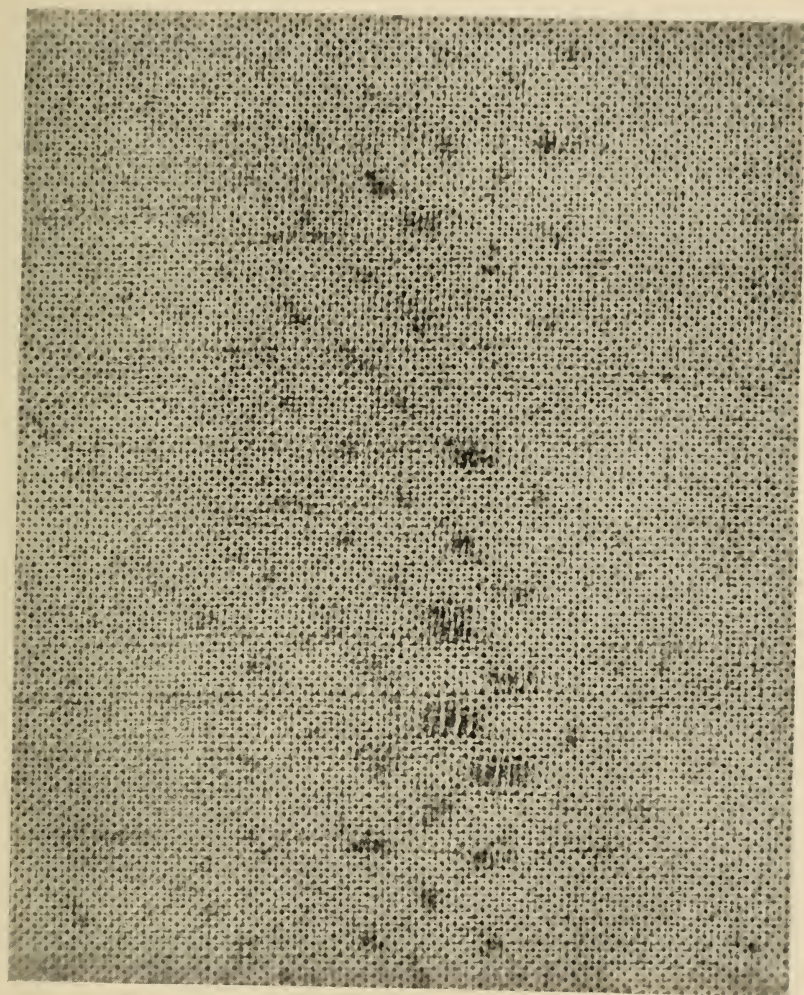
Examination of the sample submitted showed that both warp and filling threads were punctured throughout the entire piece. The series of small holes was attributed to damage by the coarse or dull pins on a wooden temple roll used on the loom. In recent years this type of temple roll has been replaced by rolls covered with rubber or other surfaces, which grip the fabric without the danger of cutting by the metal pins, particularly after they tend to become dull.

FIG. 8. Damage caused by temple roll pins.

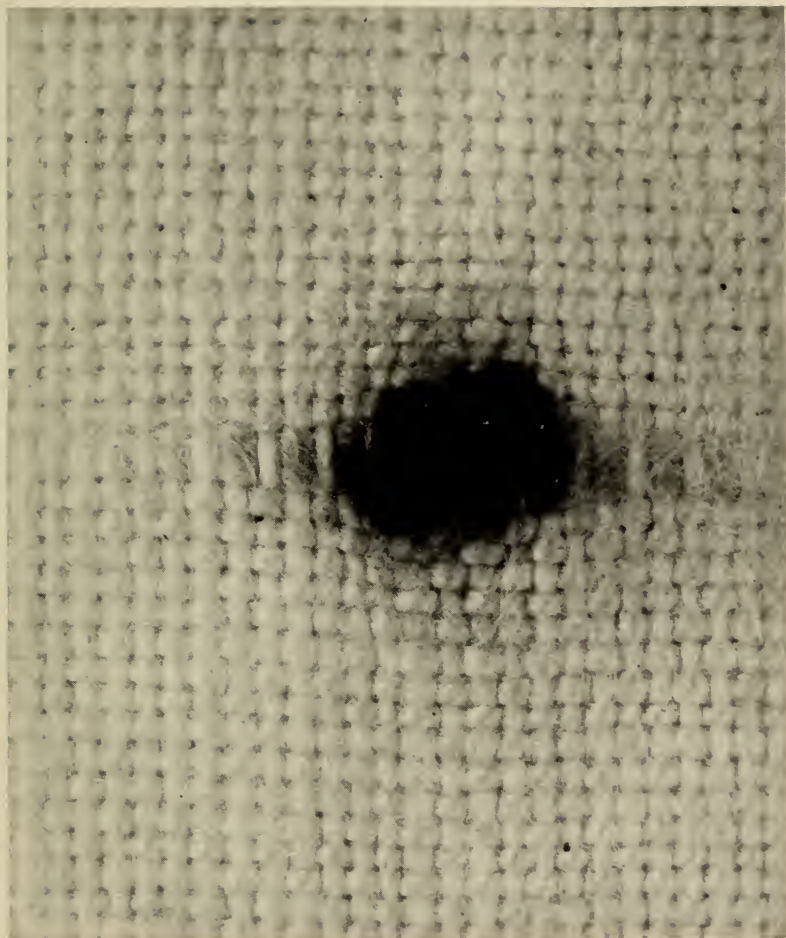
Microscopic and chemical analysis showed the black spots to be a tarlike deposit, apparently imbedded in the yarns. When warp and filling threads were unraveled in several places, it was found that the yarns contained slubs in those places, indicating that the tarry material was present in the raw cotton and prevented the proper drafting of the yarns. It was subsequently determined that this condition was being encountered in a great many cotton mills, and the contamination was traced to the black asphalt-type paint used on the cotton-bale straps. In the application of this paint, if the consistency is too thick in places, it does not dry thoroughly and parts of the sticky compound stain and adhere to any cotton with which they come in contact. It should be noted that some similar black stains in cotton fabrics have been traced to roof leaks or belt dressing and that only a chemical analysis can be relied upon to trace such stains to their true source.

FIG. 9. Asphalt stain in cotton sheeting.

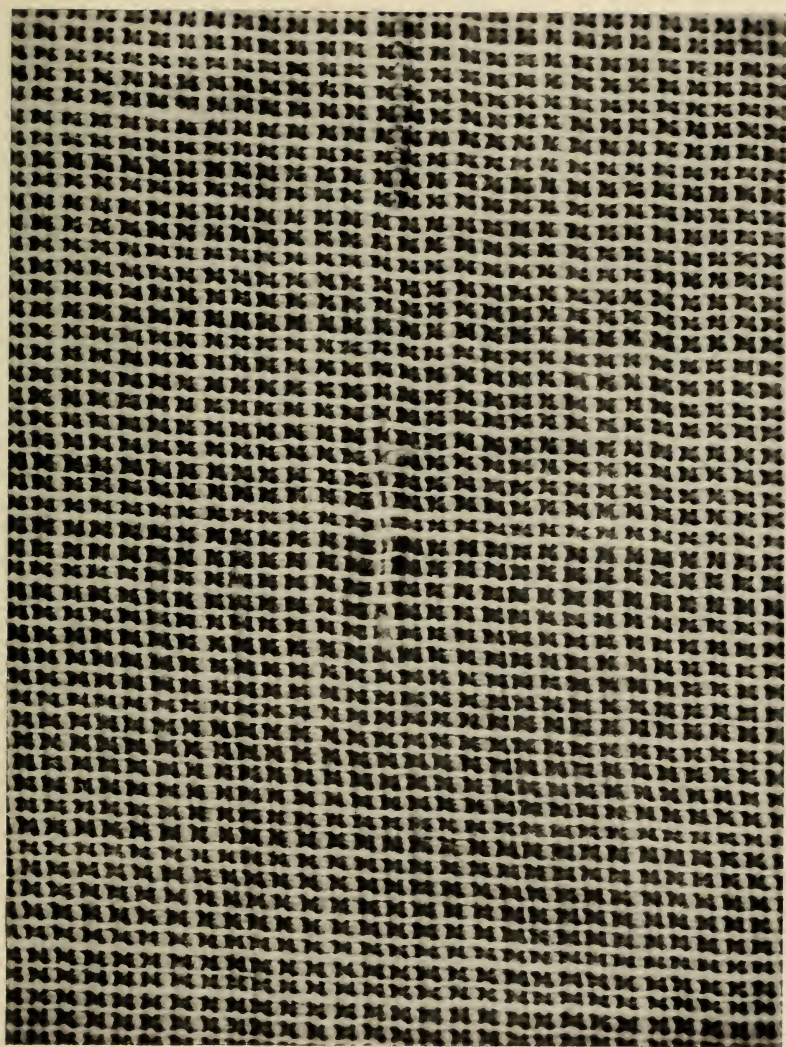
Examination showed that the floats ran in a straight line throughout the full piece at a distance of about 3 inches from one selvage, repeating at approximately 2-inch intervals. The floats were found to be due to the cutting of single picks in the faulty areas. From the nature of this defect, it was attributed to damage during weaving, probably produced by a faulty temple roll.

FIG. 10. Floats due to cut filling yarn.

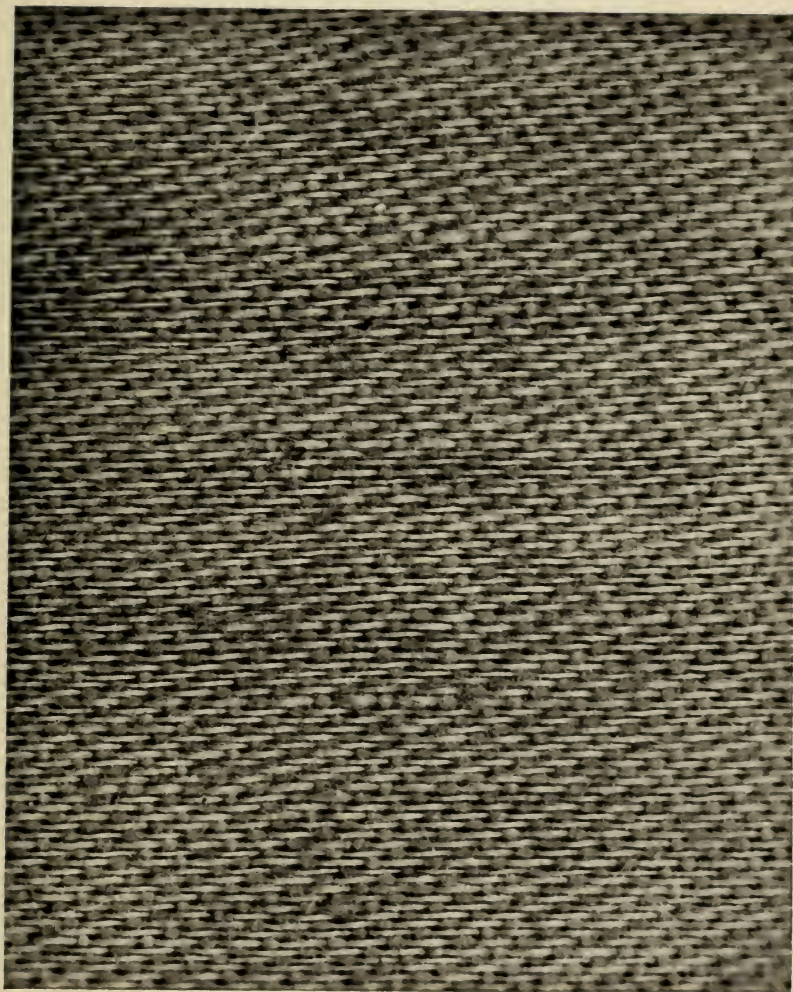
Examination of a cutting from the piece submitted showed that the warp streaks were due to differential napping of the surface. The streaks were visible on both the face and the back of the cloth. By microscopic analysis it was found that the warp yarns were unevenly spaced in those areas in a fairly regular pattern. Where the ends were closer together, the filling was apparently bound more tightly and resisted the napping. The uneven spacing of the warp yarns was due to a faulty gray-goods condition, which probably would have showed up as warp streaks in the dyed goods before napping, but the latter operation accentuated the condition.

FIG. 11. Back of napped cloth showing reedy appearance.

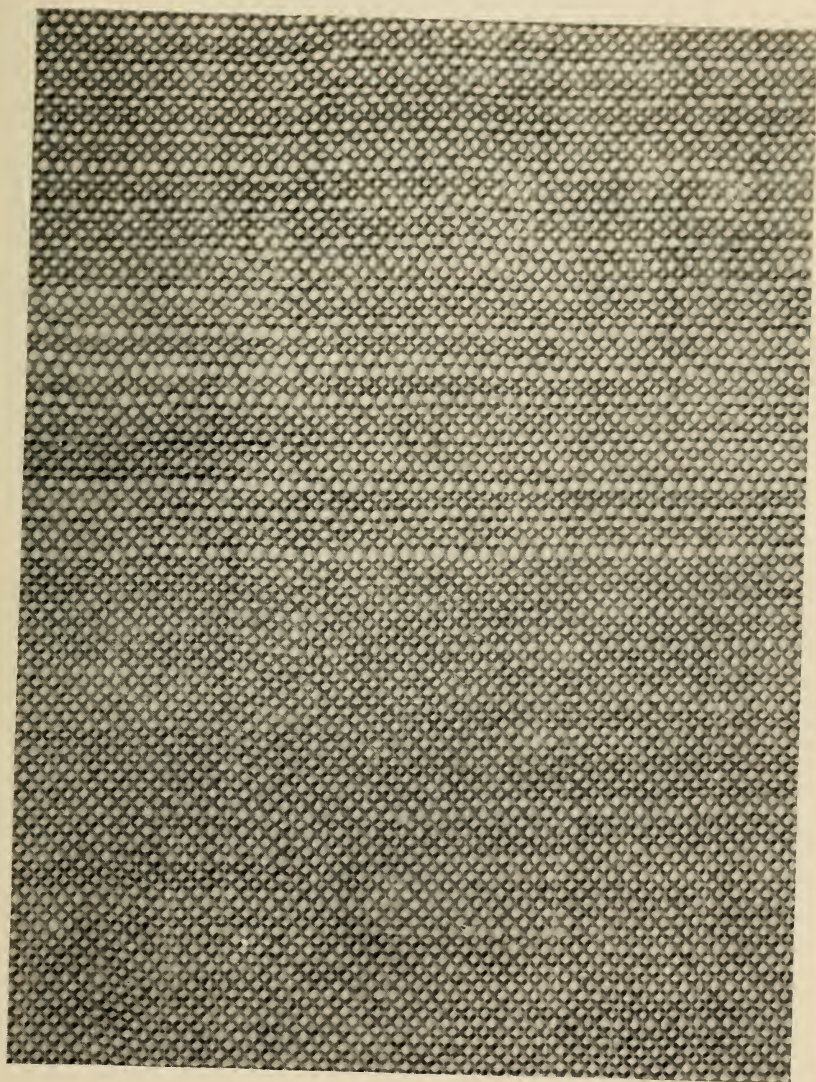
This defect was evidently due to mixing of yarns at the mill since it was learned that they were also running 30/1 yarn at the time these goods were woven.

FIG. 14. Light band due to off-size white filling yarn.

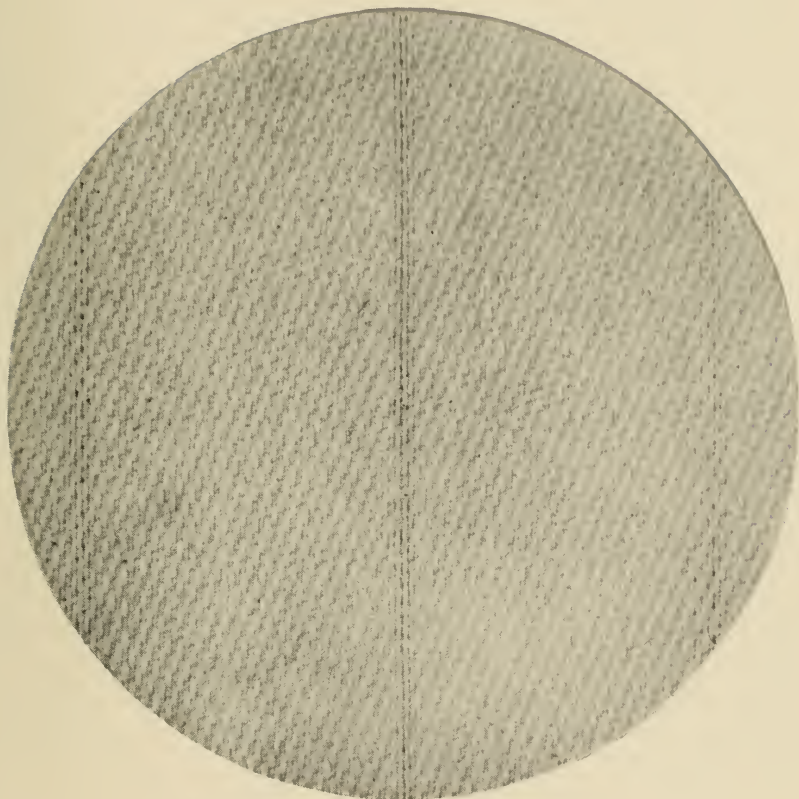
The highly twisted yarns were thinner in diameter than the normal warp ends and resulted in the appearance of warpwise cracks or streaks.

FIG. 15. Streak due to high-twist yarn.

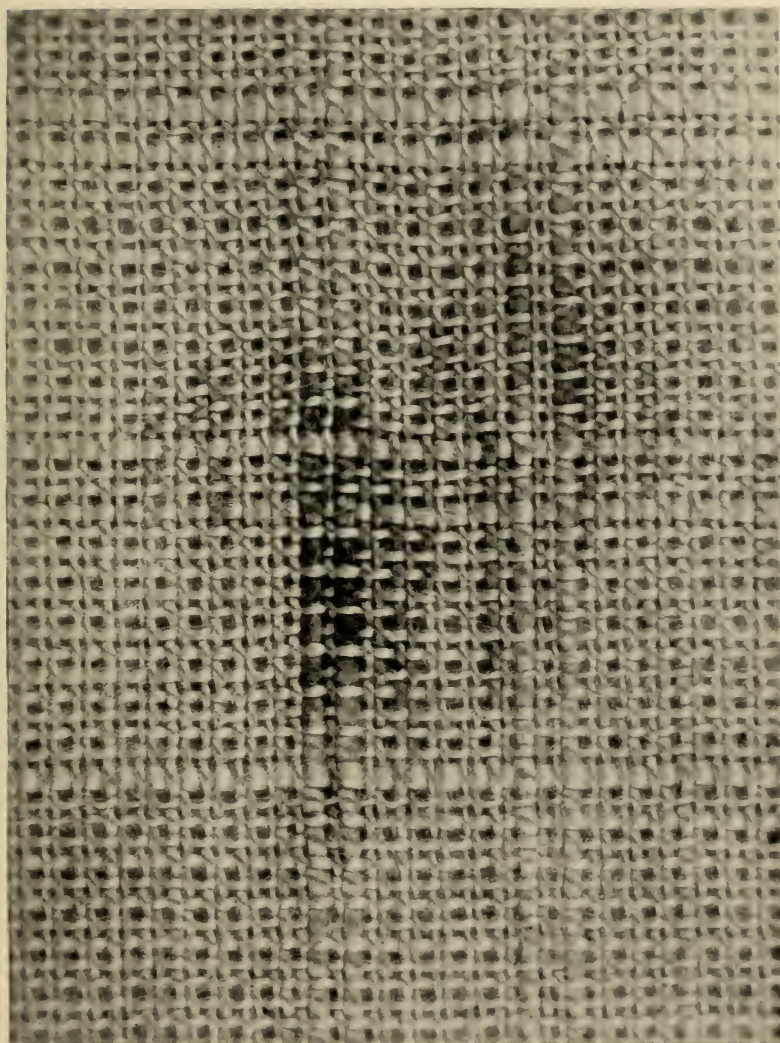
This defect was due to the contamination of the warp yarn during slashing by verdigris or copper-resist stains, the latter being formed by the reaction between copper from metal in the size tank and the free fatty acid in the warp-sizing mix. The tendering in finishing was the result of the catalytic action of the copper in producing localized overbleaching.

FIG. 16. Deposit on warp yarns.

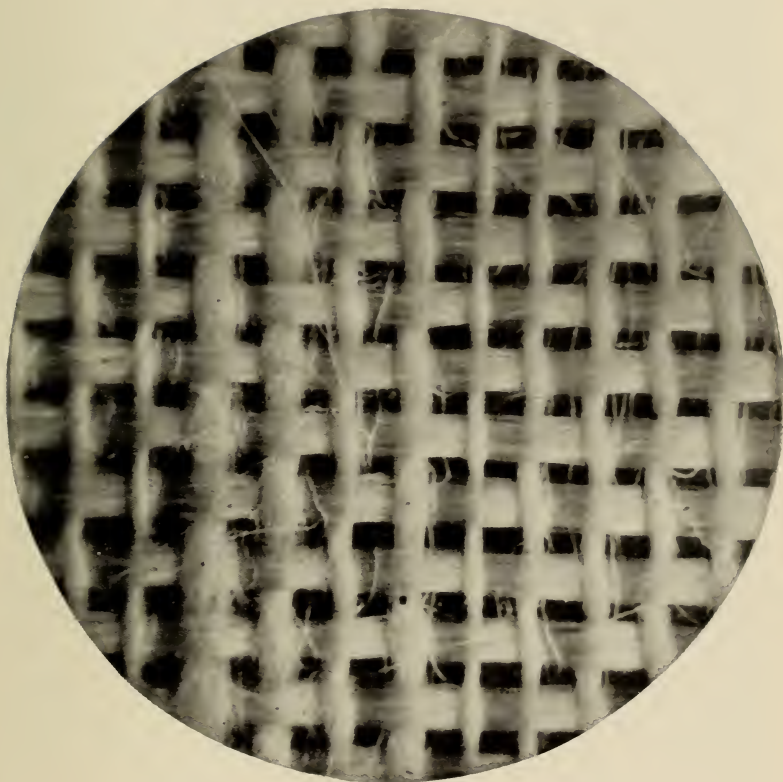
This condition was prevalent in gray goods and in boiled-off and bleached goods, as well as in the finished printed sample submitted. Examination proved it to be due to the presence of very unevenly spun warp yarns, the very thin ends sizing as fine as 38/1 and the very coarse ends as heavy as 27/1. On the gray goods' being wetted out, an almost crepelike effect was produced, resulting in the so-called "wavy" face.

FIG. 17. Uneven warp yarns causing wavy face.

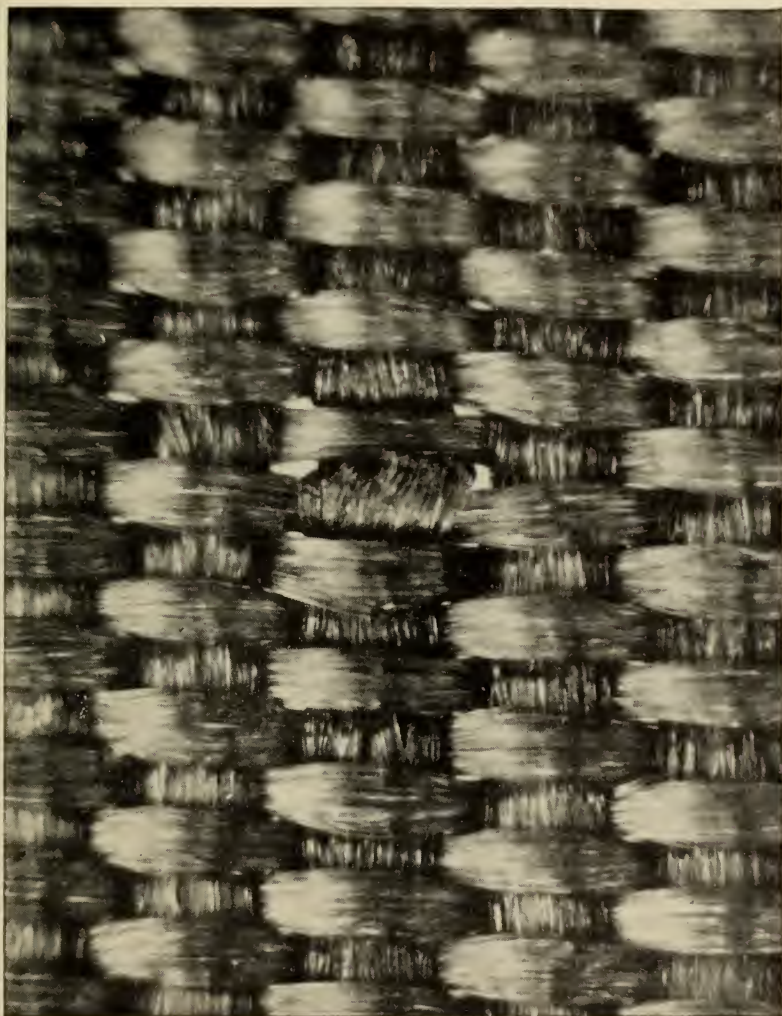
The so-called "pinholes" were found to be slightly open spaces caused by kinky filling. This is a weaving fault, sometimes caused by filling yarn's sloughing off the bobbin during weaving and generally attributed to too little tension in winding or to too low a relative humidity. In this particular case, it is interesting to note that the kinks were so inconspicuous and appeared so infrequently that they would not have been objectionable to the extent of degrading the fabric if it had been used as dress goods. The unexpected application for umbrella tops made an otherwise unimportant condition a comparatively serious imperfection.

FIG. 18. "Pinholes" due to kinky filling.

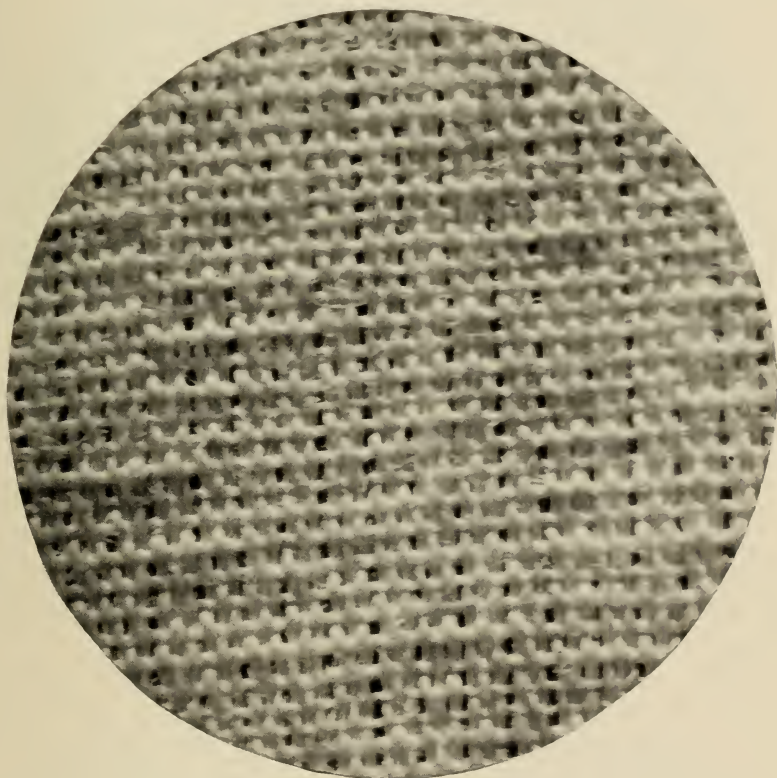
The filling ridges were found to be due to slack warp threads or to too heavy sizing on the warp yarns, preventing proper flexibility and uniform interlacing with the filling yarns. It is impossible to eliminate this defect in finishing and the cause is generally attributed to faulty warp tension during weaving or to improper warp sizing, which leaves the yarns fairly rigid. This type of defect is frequently encountered in plain, taffeta-weave, continuous-filament rayon fabrics, in which case the condition produces a "frosty" appearance.

FIG. 19. Rough face due to "tear drops."

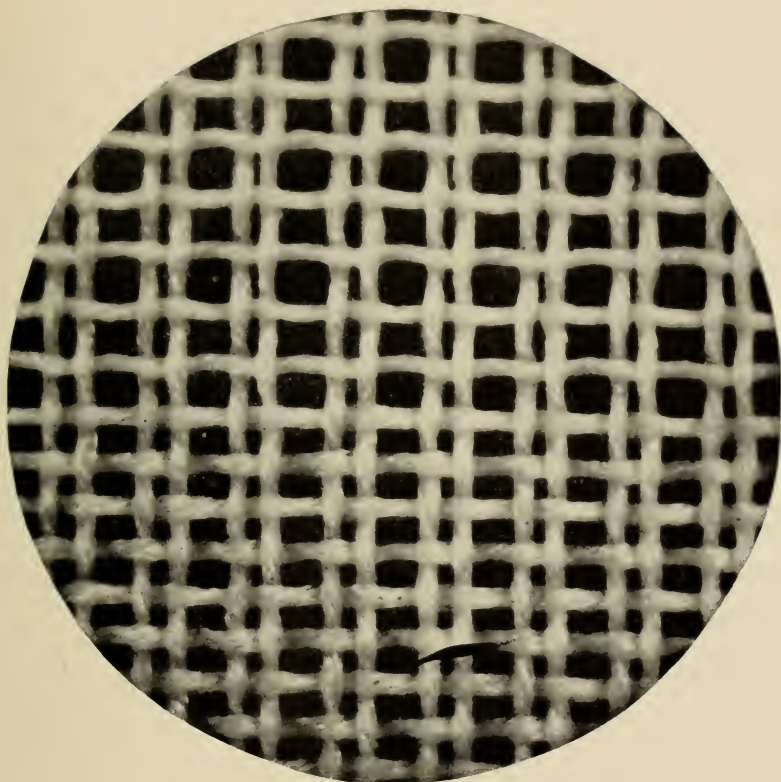
FIG. 20a. Cracky appearance in upper portion.

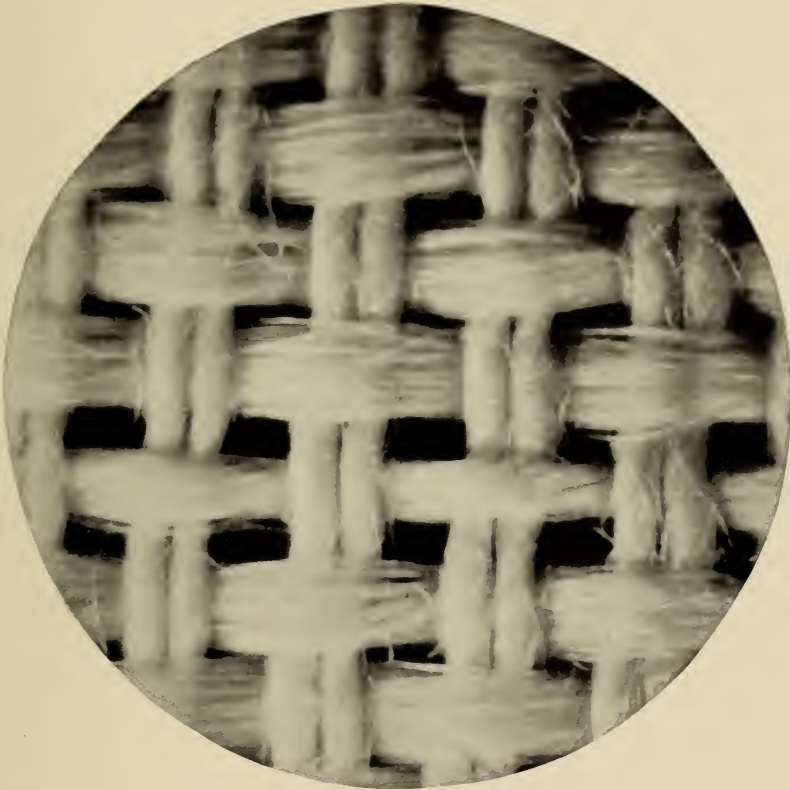
Single-strand breaking-strength and elongation tests made on the short bright sections of filling yarn showed them to have only about 18.5% residual elongation, as compared with an average of 22.5% elongation in the normal portions. On the removal of the bright-appearing yarns from the fabric, it was found that they had much less crimp than the normal yarns. Physical tests made on some of the original yarn before weaving showed it to have a normal elongation of about 24% at the breaking load. This defect was due to overstretched filling yarn, the taut section with less crimp resulting in greater light reflection and a shiny appearance. With no proof of the yarn's having been delivered to the mill in a stretched condition, it was assumed that the damage was caused by the use of excessive tension in quilling.

FIG. 21. Tight filling yarn.

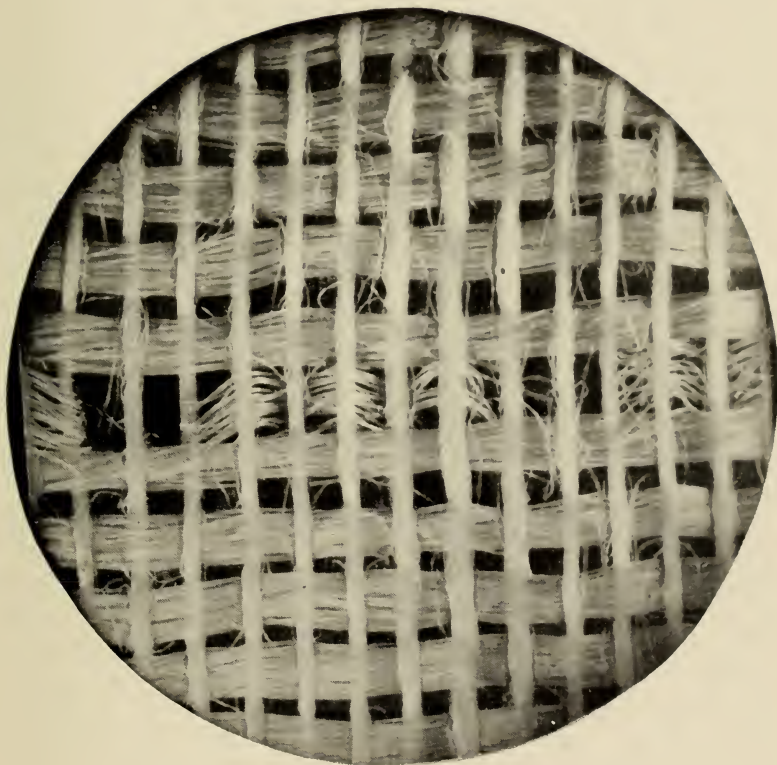
Microscopic examination showed that the holes were due to cut filling yarns. In some instances the same yarn was severed in two consecutive places across the filling. Obviously, the yarn could not have been cut in this peculiar manner at the time of weaving. This defect was traced to a condition known as "sand-roll cuts," fairly common in the early days of rayon weaving when take-up rolls covered with perforated tin, sandpaper, or card clothing were used on looms, the sharp edges cutting the delicate rayon filaments readily during weaving. In modern rayon-weaving looms, the take-up rolls are of large diameter, to minimize slippage of the cloth by providing greater surface of contact; and they are covered with crepe rubber or composition material, which grips the fabrics with no danger of cutting.

FIG. 22. Yarn cut by sand roll.

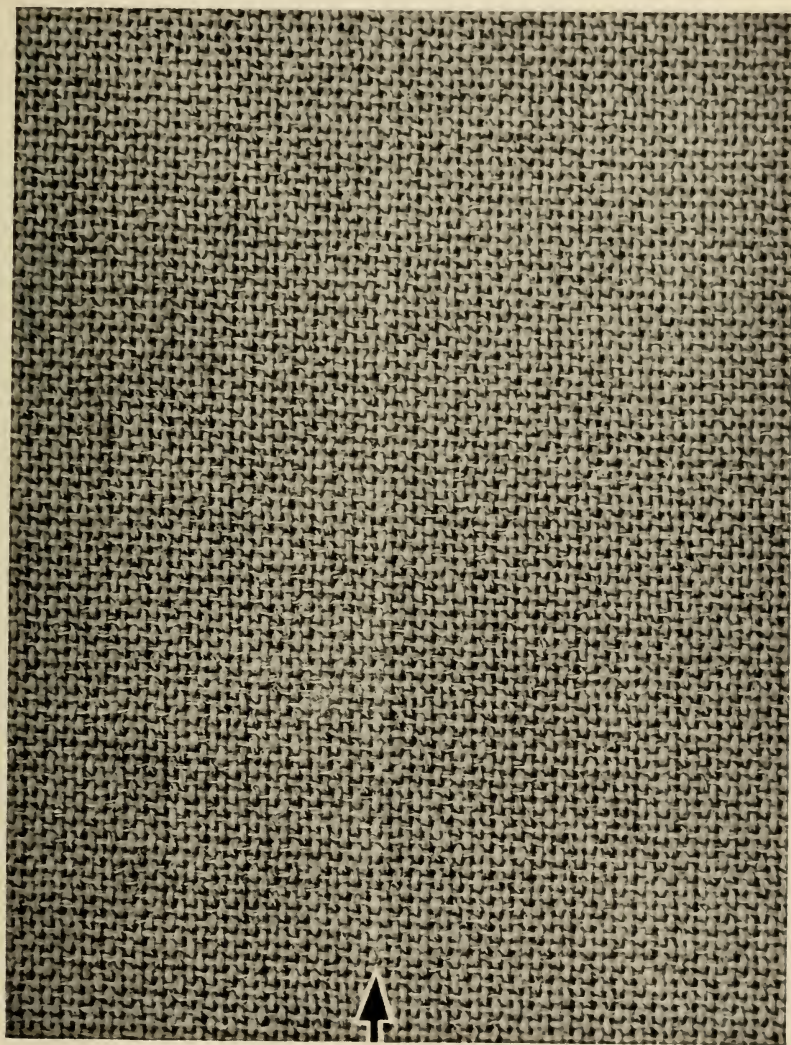
Analysis showed that the streak, which appeared to be lighter in shade than normal, was due to an end of 40-filament acetate yarn which had been accidentally introduced in one of the combination yarns instead of 60-filament yarn used in the remainder of the warp. The coarser filament yarn in this case happened to be of a different make of yarn and normally dyed lighter than the 60-filament acetate yarn. It should be noted that, while coarser filament yarns usually dye *darker* than the finer filament yarns of the same manufacturer, the dyeing differences may be the reverse when comparison is made between yarns of different origin.

FIG. 23. Streak due to wrong acetate-rayon end.

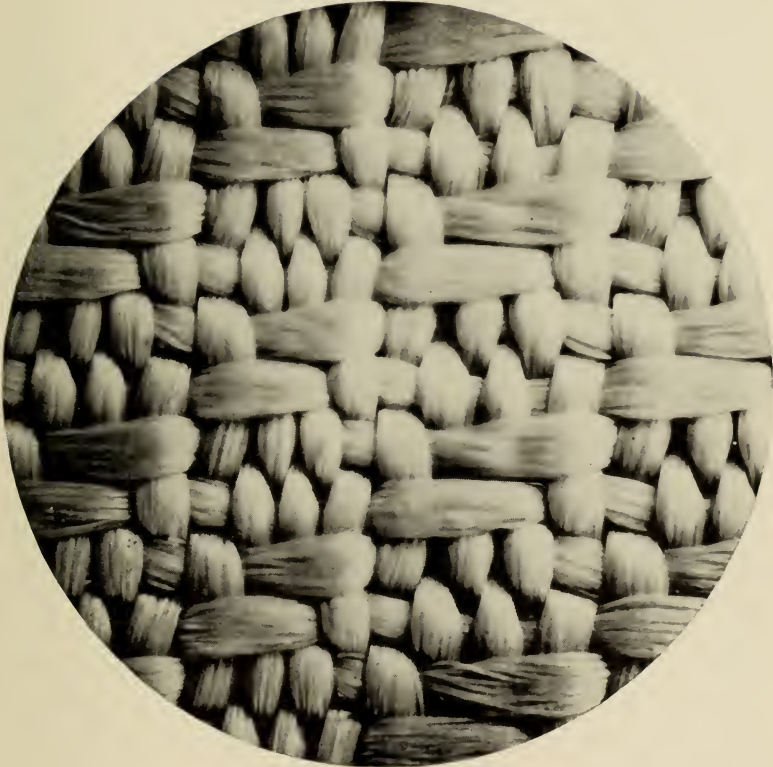
Microscopic examination showed that this condition was due to uneven spacing of the warp yarns resulting in uneven penetration of the dyestuff. This finding was confirmed by unraveling a number of warp threads and revealing the presence of warp-wise streaks on the remaining filling threads caused by greater dyestuff penetration in those areas. The uneven distribution of the warp yarns may have been due to a damaged loom reed, or to so-called "weak" dents in the reed, or to some other mechanical displacement of the normal, even spacing of the yarns.

FIG. 24. Uneven spacing of warp yarns.

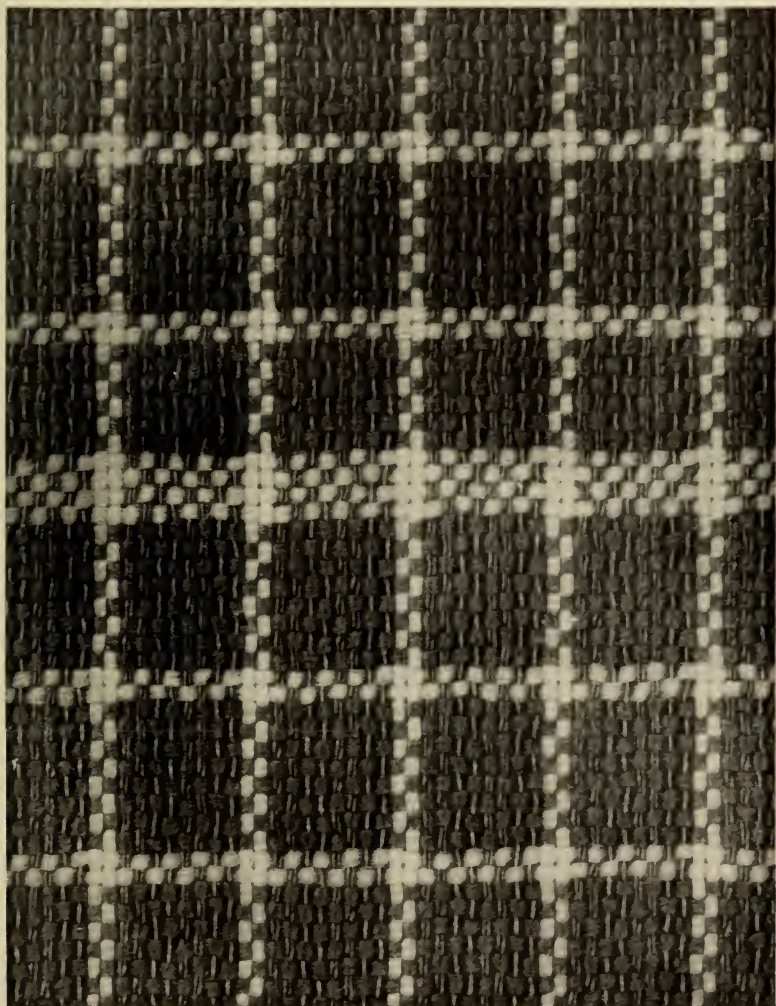
The fabric was made on a multiple-box loom in which eight picks were normally woven with the green-dyed yarn and two picks with the white-dyed yarn. In this case there were four adjacent picks of the white yarn, producing a white filling stripe that was twice the width of the normal stripe. This condition was produced by a faulty box motion on one loom, the mechanism which raised or lowered the set of shuttle boxes not functioning in the proper rotation to give the desired pattern.

FIG. 25. Additional white picks inserted by faulty box motion.

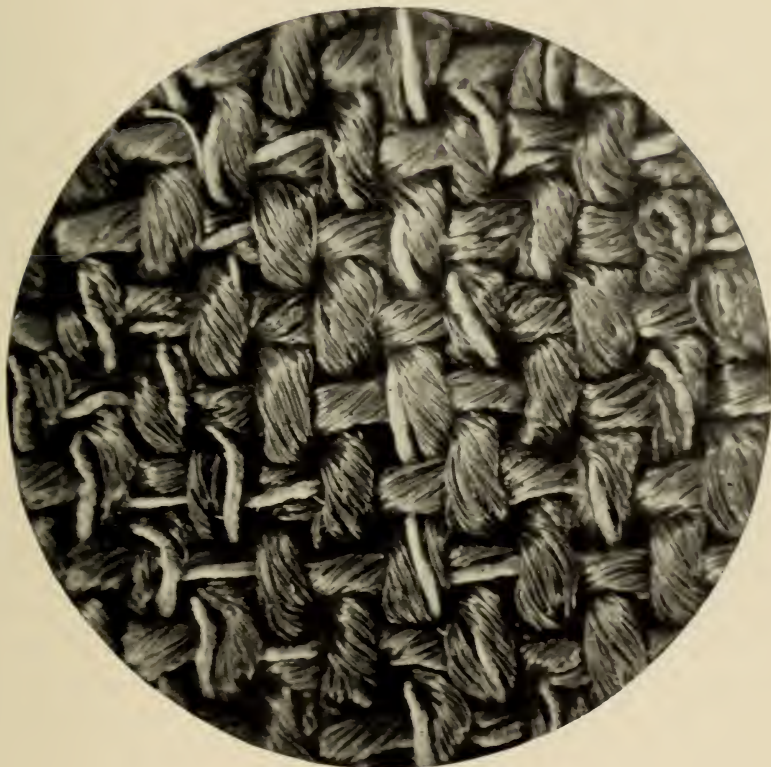
The dyestuff on a small cutting of the finished goods was stripped and the viscose component only then redyed, producing a cross-dyed effect. It was noticed that the warp streaks, coinciding with the original, were very much accentuated. This was evidence of a lack of uniformity in the proportion of viscose-crepe and acetate yarns in the plied combination. Analysis of the twist confirmed this finding, in some cases there being as much as 50% difference in the contraction of the creped-yarn component, as compared with the normal nonstreaky combination ends. This defect is accentuated when the dyestuff penetration is poor or the color match between the acetate and the viscose is not perfect. In this particular case, however, the color match was found to be reasonably good and commercially acceptable.

FIG. 26. Uneven ply-twist contraction.

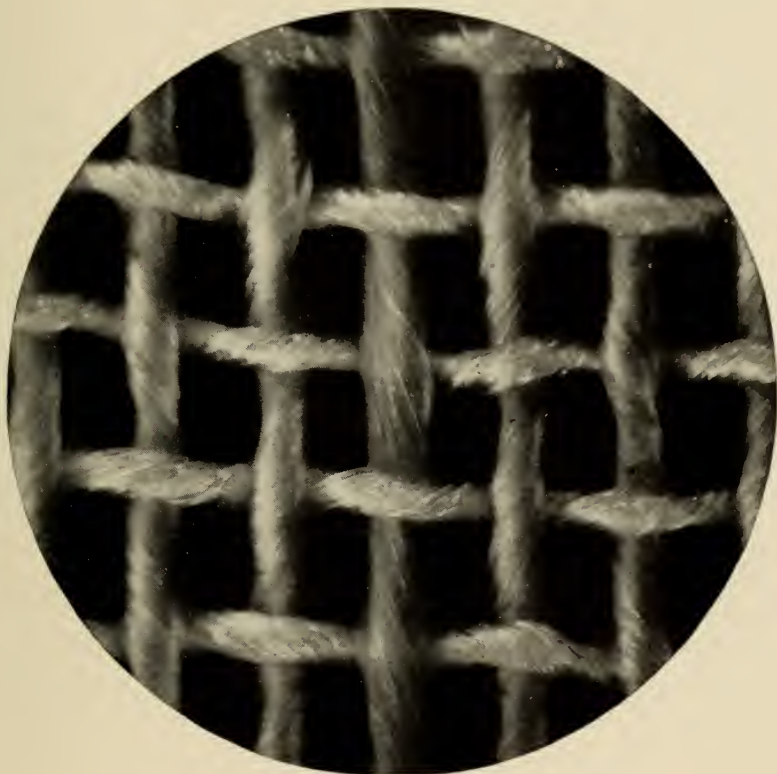
Microscopic examination showed that the bright, single warp streaks were due to sections of warp yarns with much less twist than the remainder of the yarns. Twist determinations were made and the slack portions were found to have only about 30 turns per inch, instead of the normal specified 55 turns. The defective portions were found to be present in both S- and Z-twist yarns. When the sample was examined microscopically, a number of continuous warp streaks were detected, resulting from wrong draws, but this defect was not so noticeable as the faulty twist and apparently was not reported by the cutter.

FIG. 27. Low twist in single warp yarn.

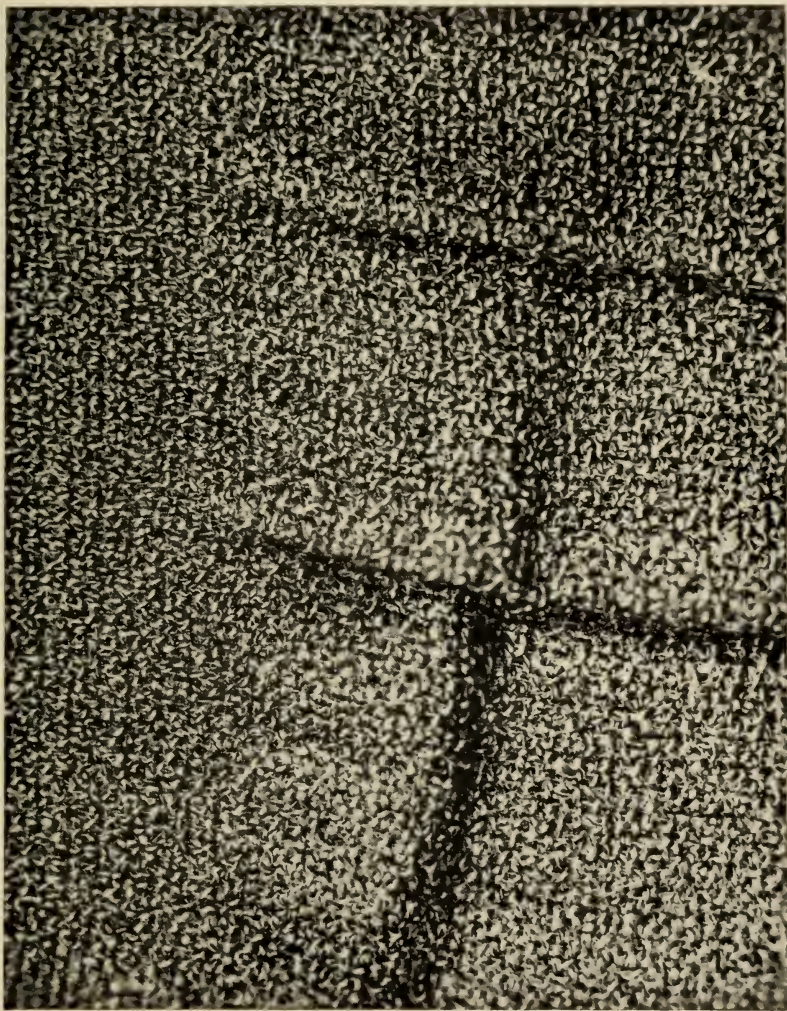
In the narrow puckered areas, the filling crepe yarn was found to have all S twist instead of alternating with two picks of Z twist, as specified. This concentration of unbalanced one-way twist resulted in a higher filling shrinkage, producing the puckered, or *plissé*, effect, generally called "trammage."

FIG. 28. Warpwise creases due to band of filling with all one-way twist.
